**NASA TECHNICAL
MEMORANDUM**

NASA TM X-53805

**INVESTIGATION OF ELECTROPLATING PROCEDURES FOR
MAGNESIUM LITHIUM ALLOYS**

By James R. Lowery and Gayle F. Mitchell
Propulsion and Vehicle Engineering Laboratory

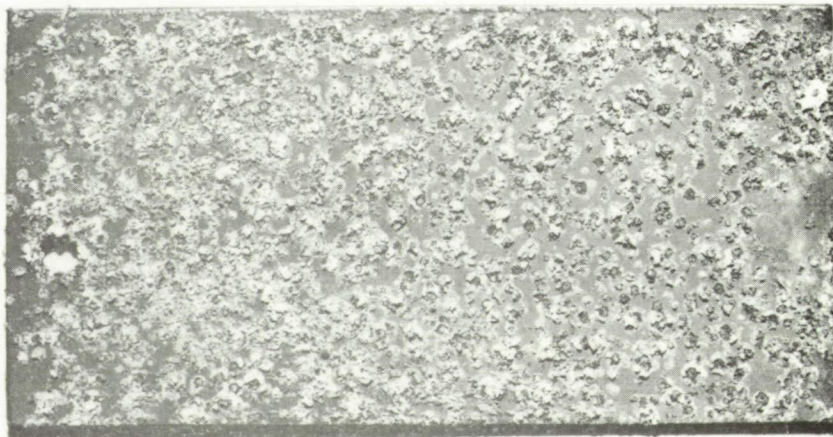
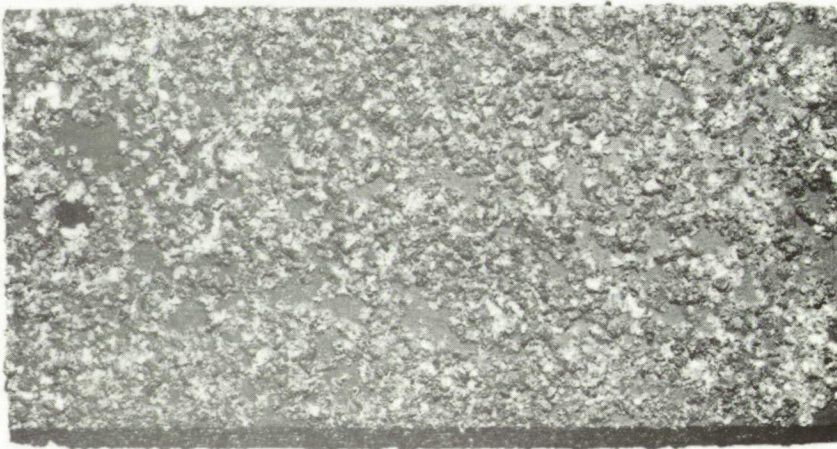
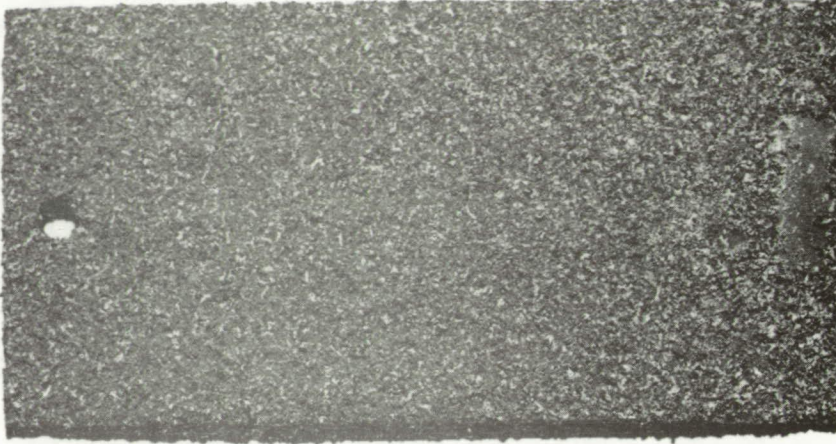
FIGURE 1 - SALT SPRAY TESTS OF GOLD PLATED MAGNESIUM ALLOYS. EXPOSURE TIME - 4 HOURS

Salt spray. After a total of 4 hours exposure time, all specimens showed severe surface corrosion. No significant difference in the amount of corrosion was observed between the three different alloys for any of the three platings systems (FIGs. 1, 2, and 3). Overall, the nickel plating provided slightly more corrosion protection than the two other plated coatings, particularly around the edges of the panels. Corrosion occurred on all test panels much sooner than was expected and as a result, the early stage of corrosion was not observed. Because of this, and because of the severity of corrosion in such a relatively short period of time, a decision was made to repeat the salt spray tests with specimens plated to greater thicknesses. In this repeat test, the gold was plated to a thickness of 0.0005 inch and the nickel and cadmium to a thickness of 0.002 inch. Other aspects of the test were identical to the first one that was performed. After one hour of exposure time, each of the gold plated alloys again showed severe corrosion, and there was no significant difference in the amount of corrosion shown in either of the three different alloys (FIG 4). A considerable amount of corrosion was also present on the cadmium plated LA-141 panels after one hour exposure but none was observed on the cadmium plated alloys of LAZ-933 and AZ31B. No corrosion was observed on either of the three different alloys that were nickel plated after one hour exposure.

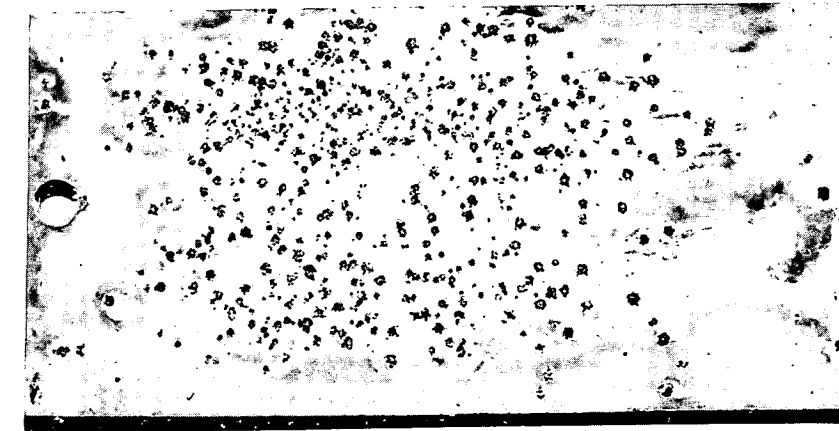
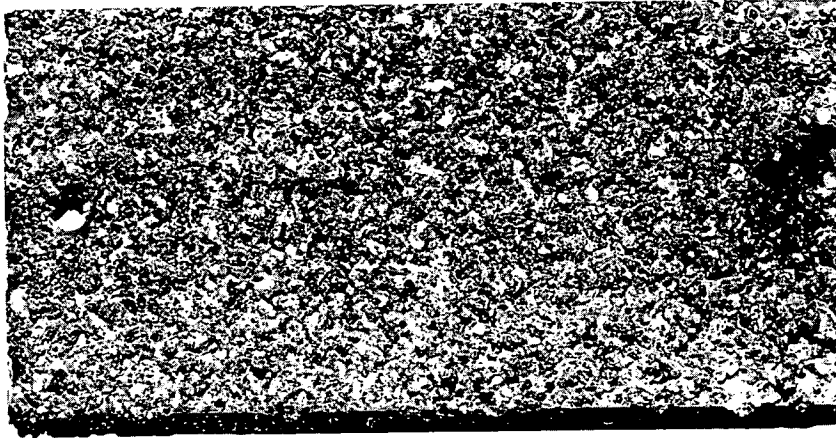
FIGURE 2 - SALT SPRAY TESTS OF CADMIUM PLATED MAGNESIUM ALLOYS. EXPOSURE TIME - 4 HOURS

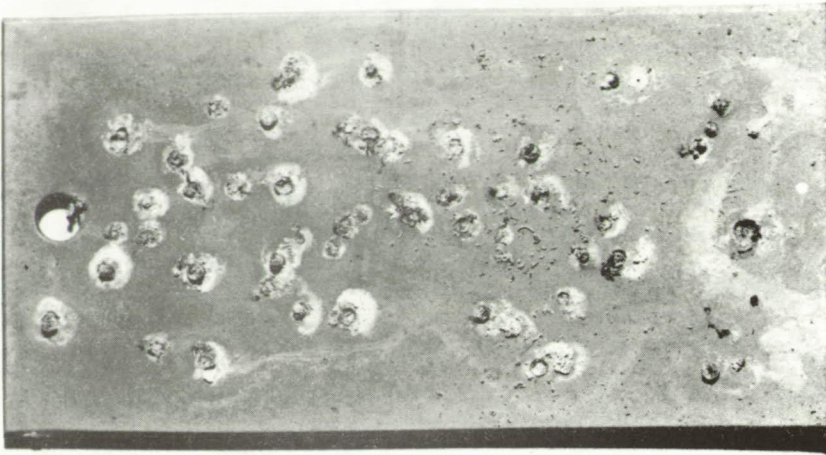
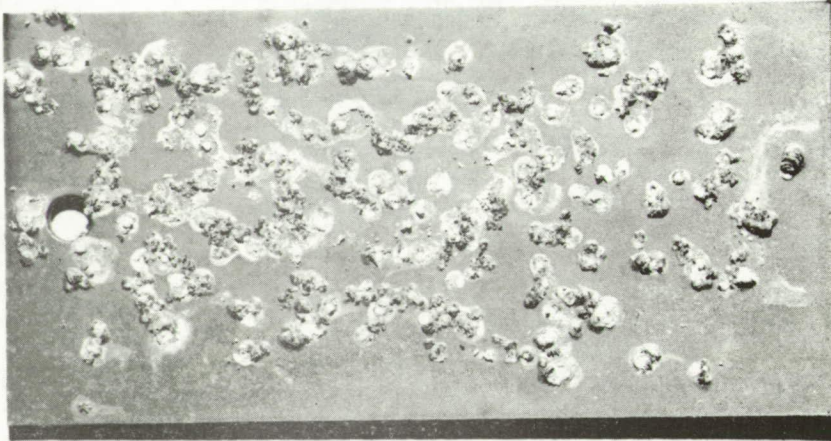
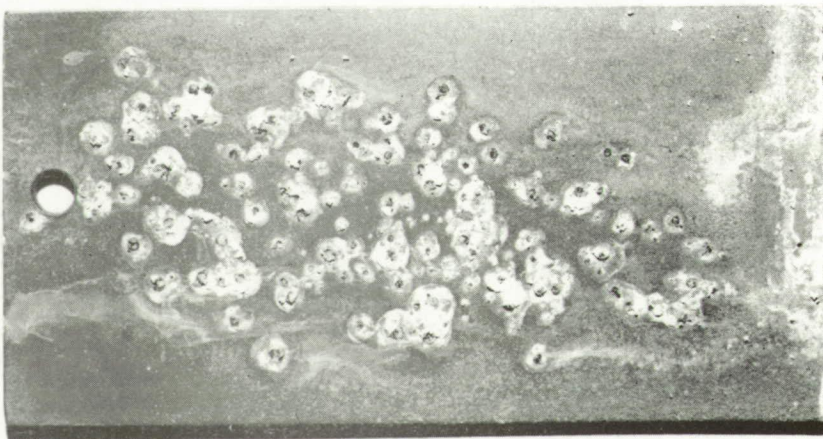
FIGURE 3 - SALT SPRAY TESTS OF NICKEL PLATED MAGNESIUM ALLOYS. EXPOSURE TIME - 4 HOURS

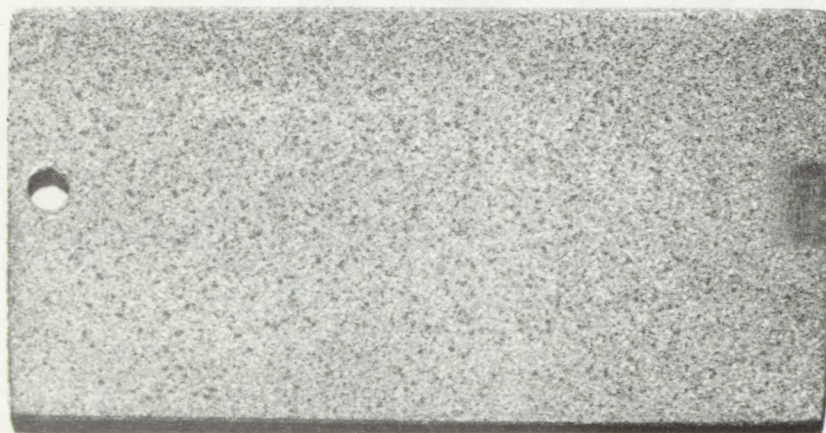
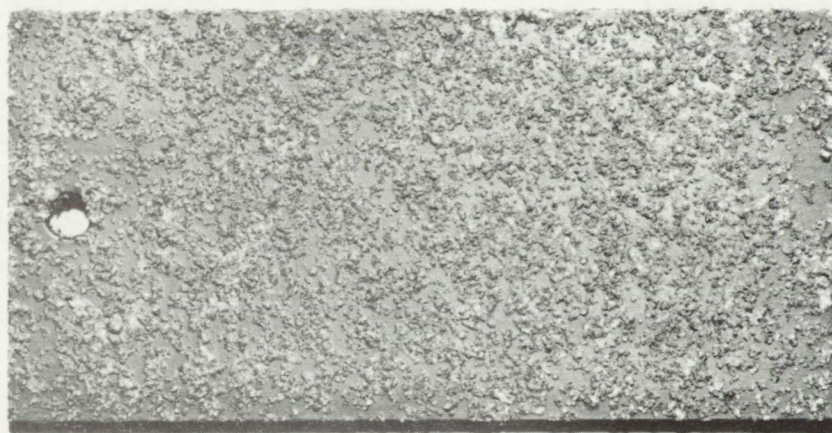
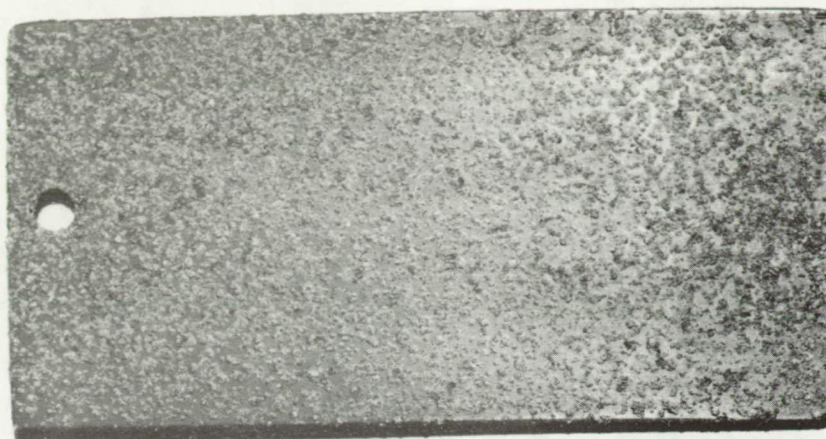
**FIGURE 4 - SALT SPRAY TESTS OF GOLD PLATED MAGNESIUM
ALLOYS. EXPOSURE TIME - 1 HOUR**

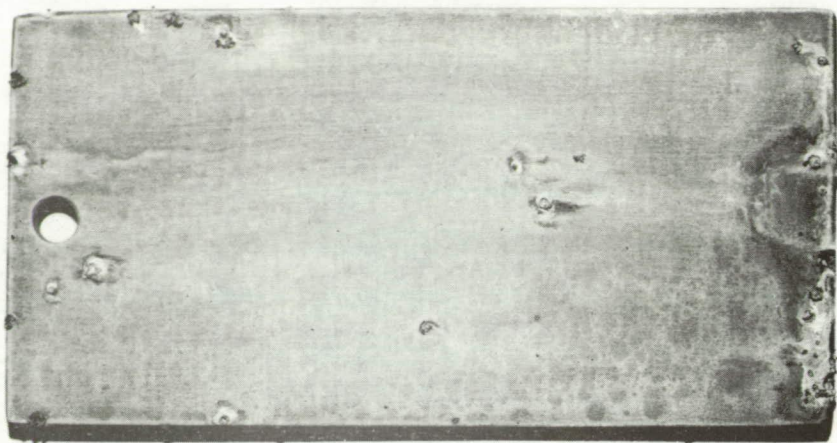
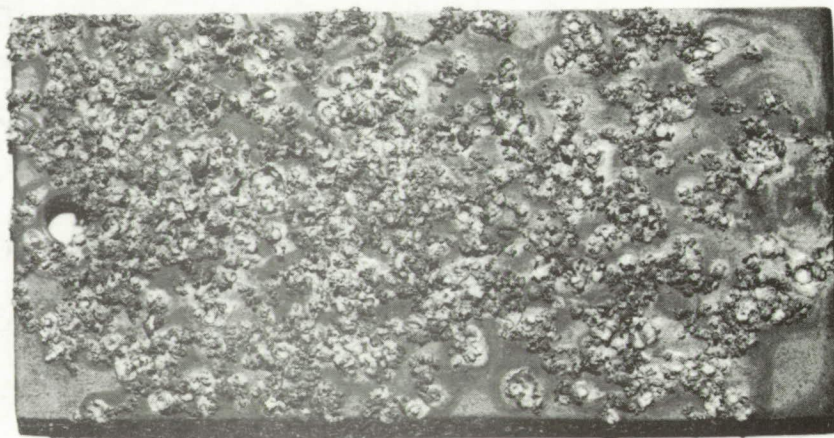
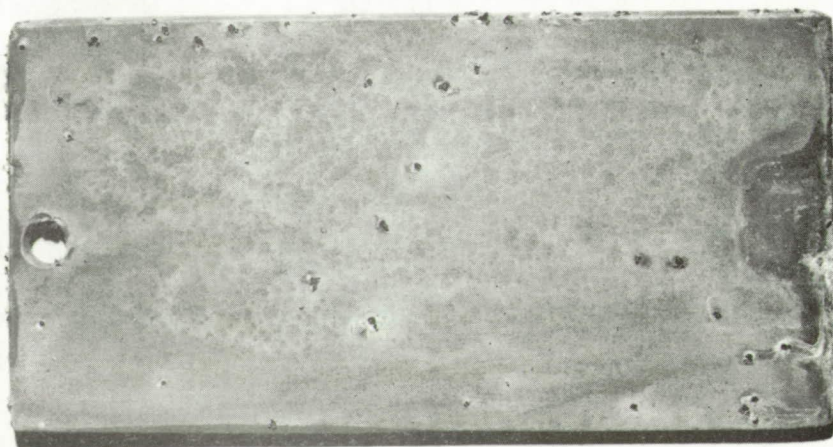
FIGURE 5 - SALT SPRAY TESTS OF CADMIUM PLATED MAGNESIUM ALLOYS. EXPOSURE TIME - 5 HOURS

No further salt spray testing was done on the gold plated panels after one hour exposure time, but the nickel and cadmium plated panels were subjected to the salt spray environment for an additional 4 hours. At the end of this test period (5 hours total) the cadmium plated panels of LA-141 alloy showed severe corrosion and considerably more than the cadmium plated alloys of AZ31B and LAZ-933 which showed about the same amount (FIG 5). No significant corrosion was observed at the end of the 5-hour test period on any of the three different alloys that were nickel plated (FIG 6). (In the photograph, the rough appearance of panel edges resulted from high current density areas).

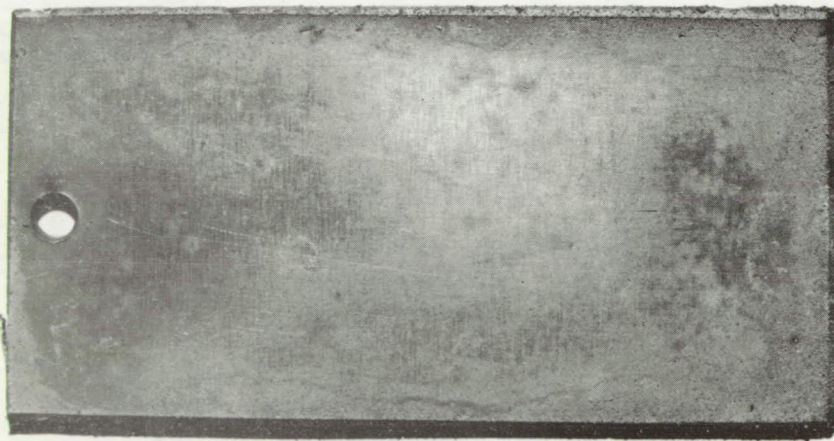
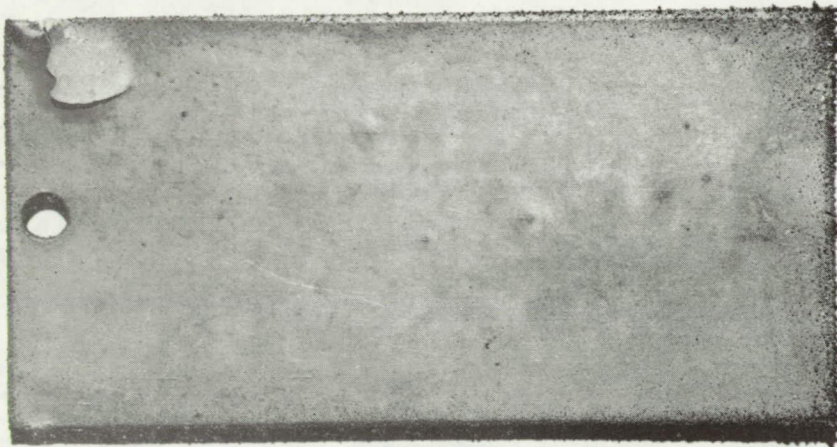
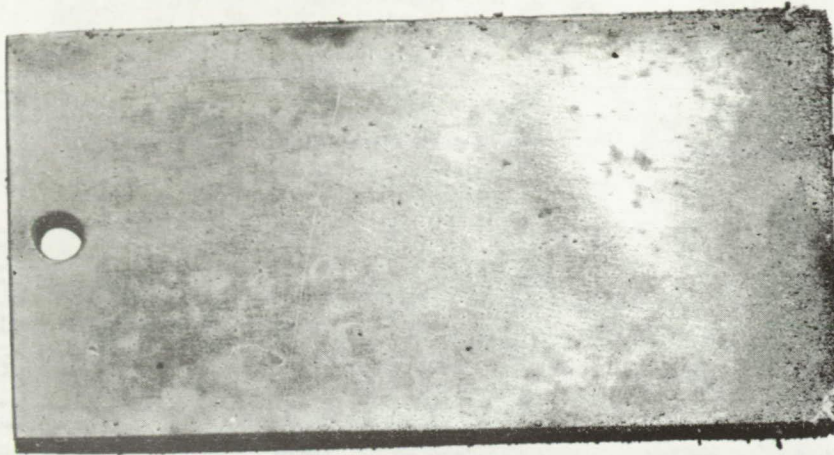
**FIGURE 6 - SALT SPRAY TESTS OF NICKEL PLATED MAGNESIUM
ALLOYS. EXPOSURE TIME - 5 HOURS**

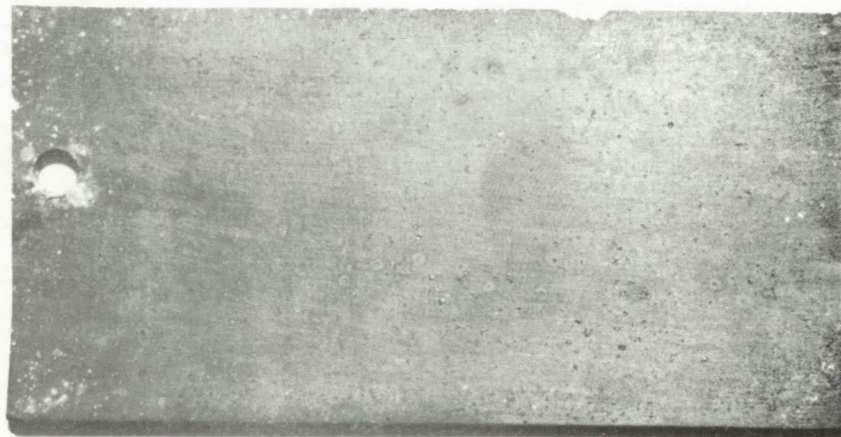
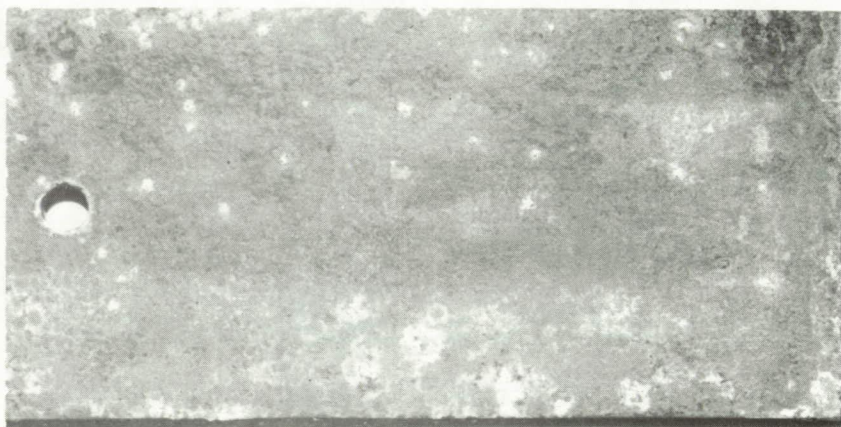
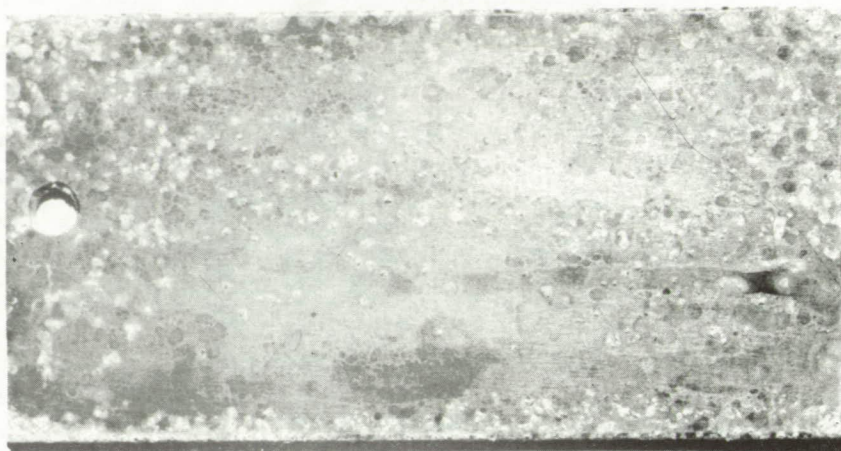
**FIGURE 7 - ENVIRONMENTAL TESTS OF GOLD PLATED MAGNESIUM
ALLOYS. EXPOSURE TIME - 336 HOURS**

After a total of 336 hours exposure time, the gold plated panels of alloy LAZ-933 showed severe corrosion while gold plated panels of AZ31B and LA-141 showed light to moderate amounts of corrosion, but much less severe than that shown on alloy LAZ-933 (FIG 7).

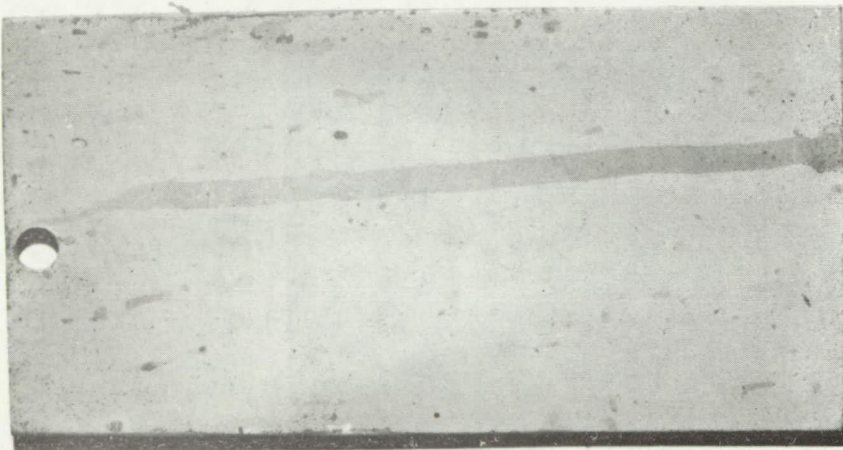
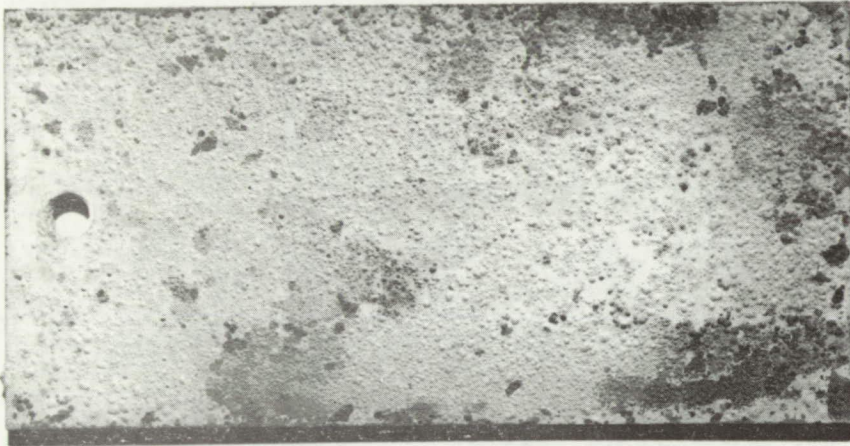
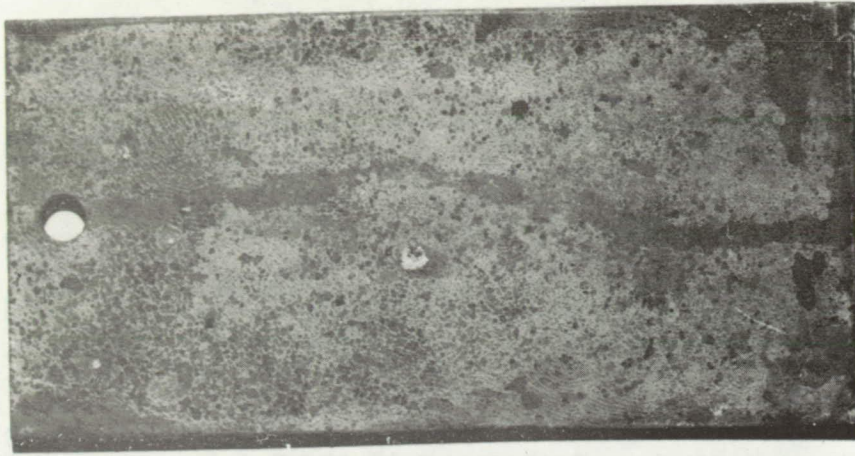
FIGURE 8 - ENVIRONMENTAL TESTS OF CADMIUM PLATED MAGNESIUM ALLOYS. EXPOSURE TIME - 336 HOURS

At the end of the 336-hour test period, cadmium plated panels of alloy AZ31B showed essentially no corrosion, while cadmium plated panels of alloys LAZ-933 and LA-141 showed very light corrosion and some discoloration which was about the same on each of the two alloys. Numerous small blisters were also noted on panels of LA-141 and LAZ-933 which was not observed on the cadmium plated AZ31B alloy (FIG 8).

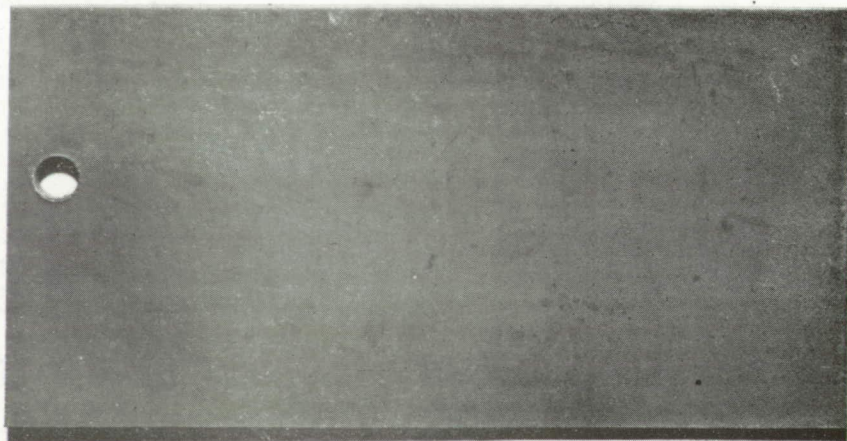
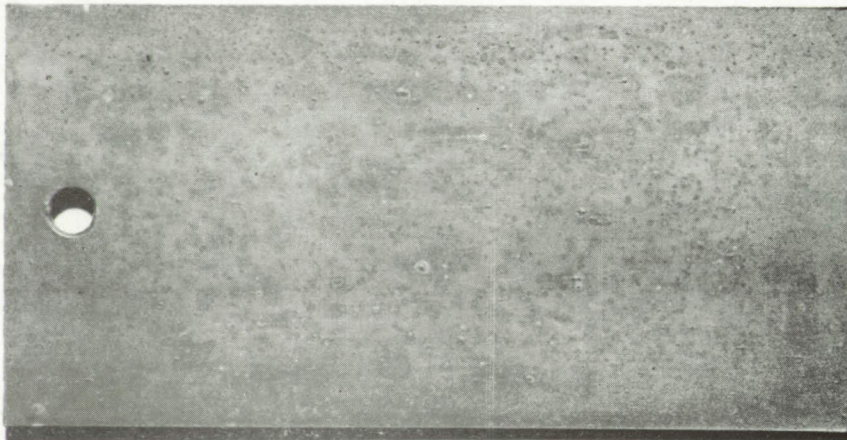
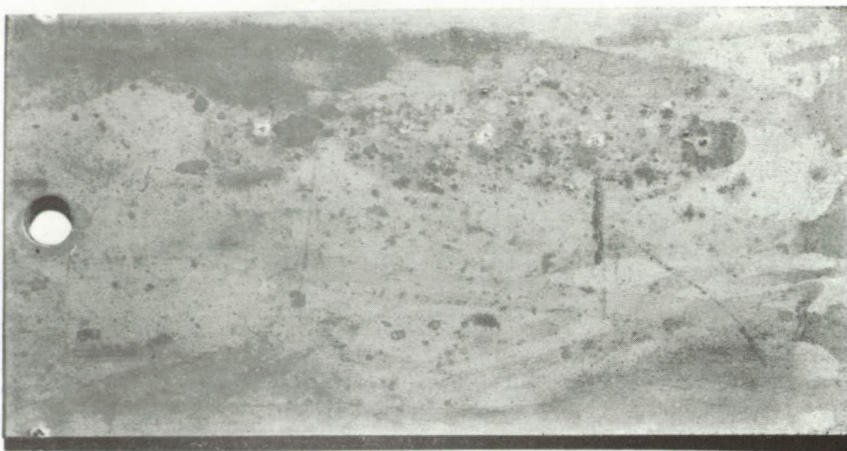
**FIGURE 9 - ENVIRONMENTAL TESTS OF NICKEL PLATED MAGNESIUM
ALLOYS. EXPOSURE TIME - 336 HOURS**

At the end of the test period, nickel plated panels of alloy AZ31B showed essentially no corrosion. Alloy LAZ-933, plated with this metal, showed a few spots of corrosion, while the nickel plated panels of alloy LA-141 exhibited light corrosion that covered the entire panel (FIG 9).

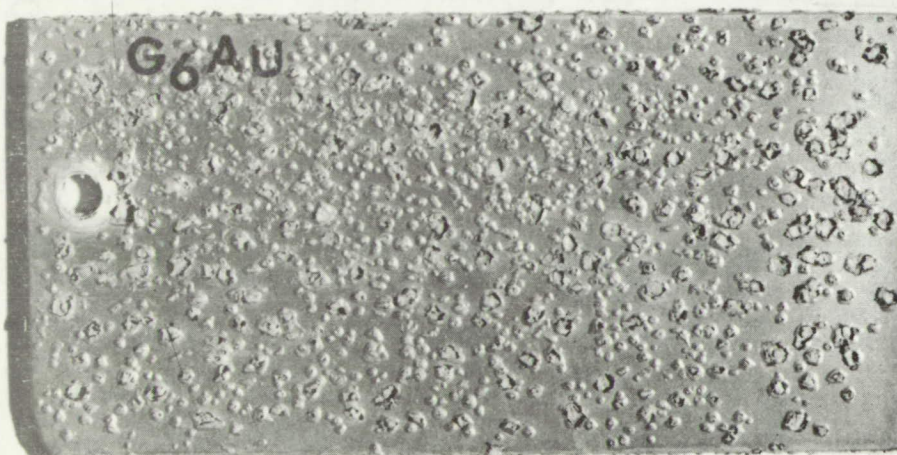
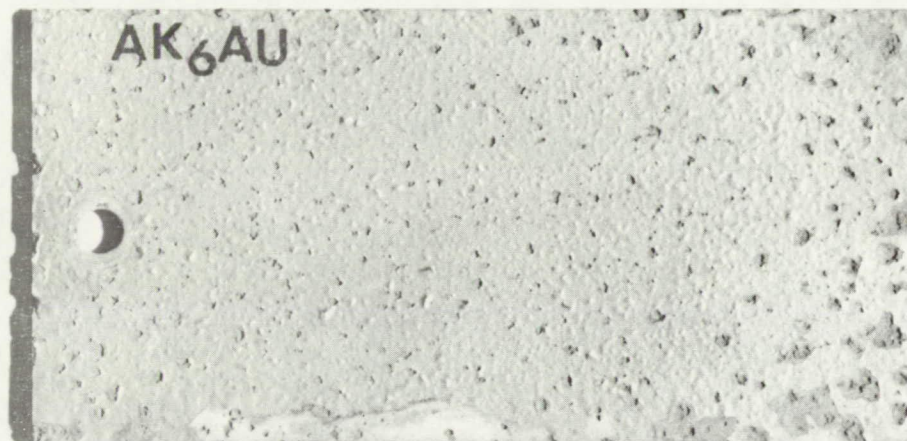
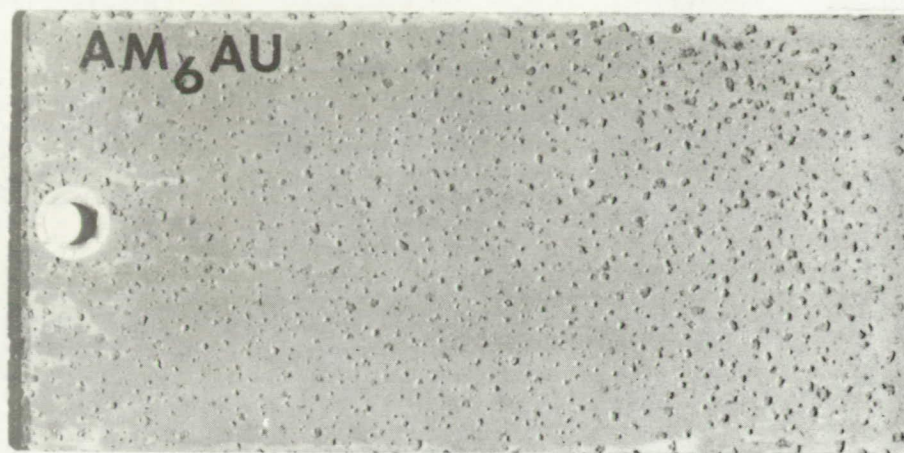
**FIGURE 10 OUTDOOR EXPOSURE TESTS OF GOLD PLATED MAGNESIUM ALLOYS.
EXPOSURE TIME - 18 MONTHS**

Atmospheric (outdoor). After a few weeks of exposure to this environment, either blisters or some form of light corrosion was observed on all panels except those of alloy AZ31B that were cadmium plated. The gold plated panels were essentially covered with small blisters while most of the other panels showed spots of white corrosion.

As exposure time was increased, the blisters on the gold plated panels burst, the gold partially flaked, and corrosion gradually became worse. After a total of 18 months exposure, the gold plated panels showed severe corrosion and pitting with each alloy exhibiting about the same degree of degradation (FIG 10).

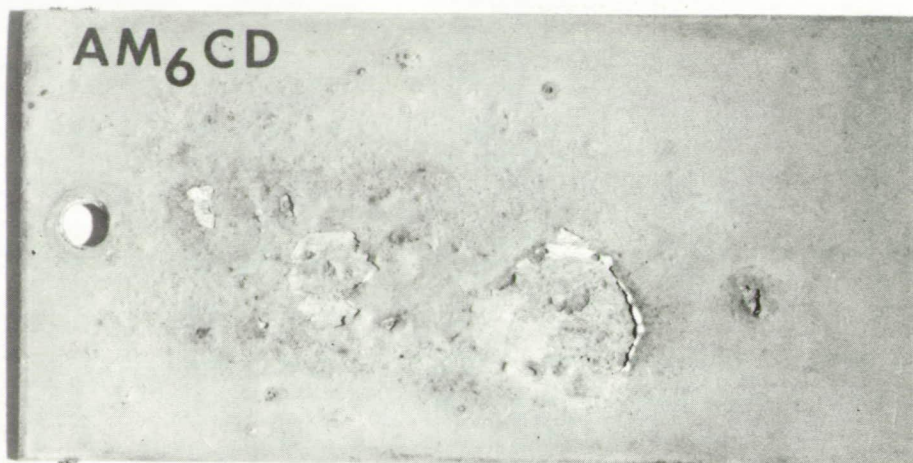
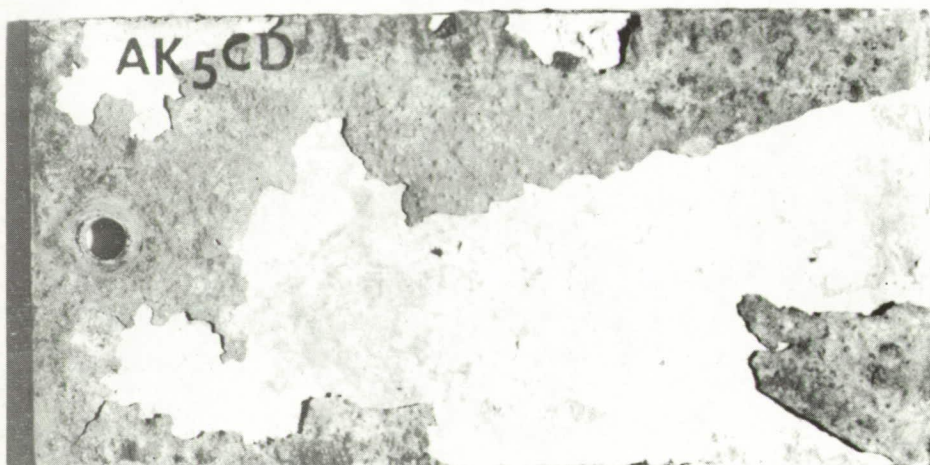
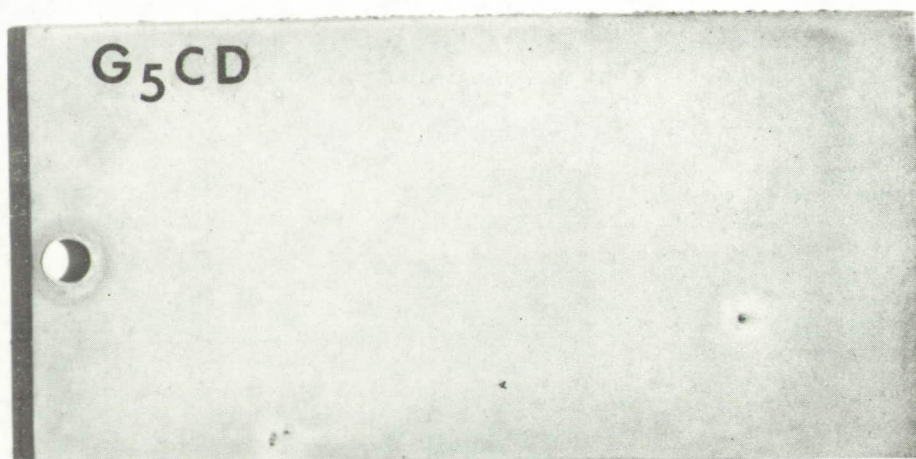
**FIGURE 11 OUTDOOR EXPOSURE TESTS OF CADMIUM PLATED MAGNESIUM ALLOYS.
EXPOSURE TIME - 18 MONTHS**

The cadmium plated panels of alloy AZ31B showed essentially no corrosion at the end of the 18 months test period. On the contrary, cadmium plated panels of alloys LAZ-933 and LA-141 were severely corroded. In the case of the LA-141 alloy, the cadmium electroplate was lifted from the substrate and, for the most part, removed from the base metal (FIG 11).

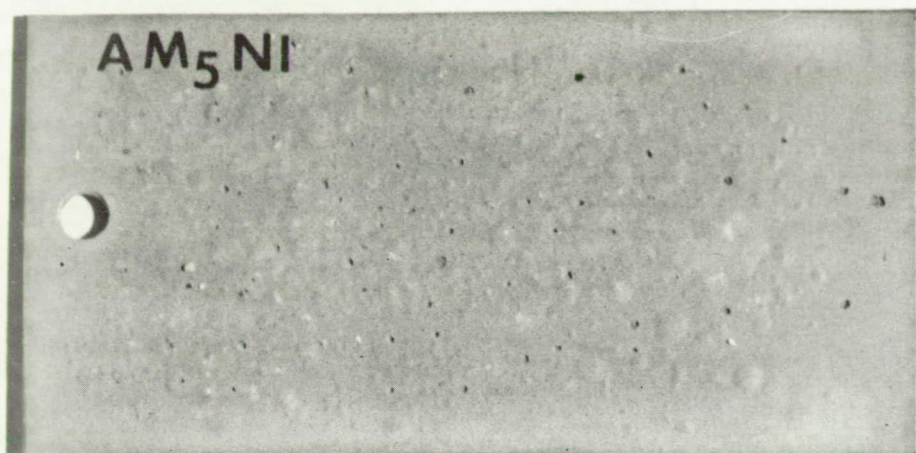
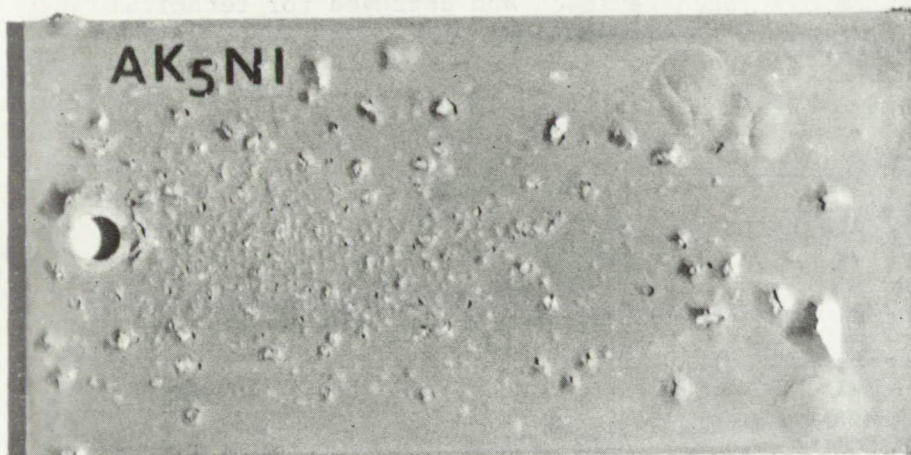
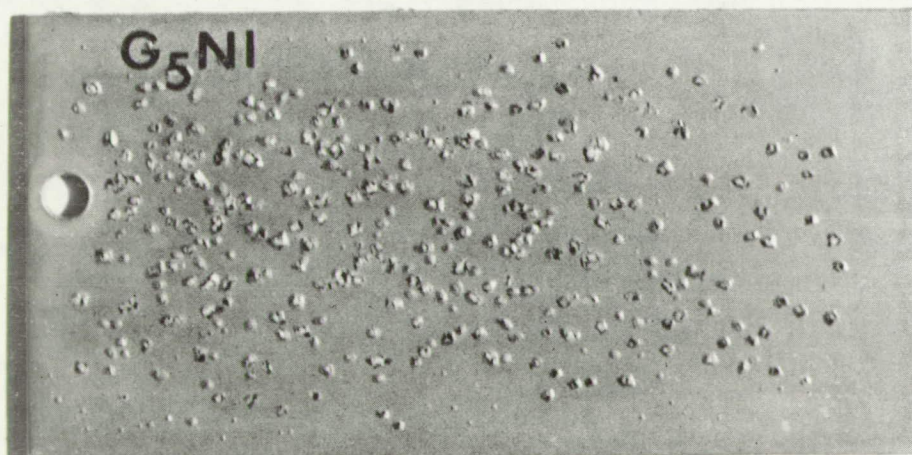
FIGURE 12 OUTDOOR EXPOSURE TESTS OF NICKEL PLATED MAGNESIUM ALLOYS.
EXPOSURE TIME - 18 MONTHS

The nickel plated panels showed a considerable amount of corrosion but there was no significant difference in the amount shown on each of the three different alloys (FIG 12). The corrosion was initiated, for the most part, from small blisters that formed in the early stages of the test that gradually burst and consequently exposed the bare metal.
